# **NERC IBR Reports and Activities**

**ERCOT Technical Advisory Committee  
NOGRR245 Meeting  
May 10, 2024**

**Texas Reliability Entity, Inc.  
Mark Henry, David Penney, and Joseph Younger**

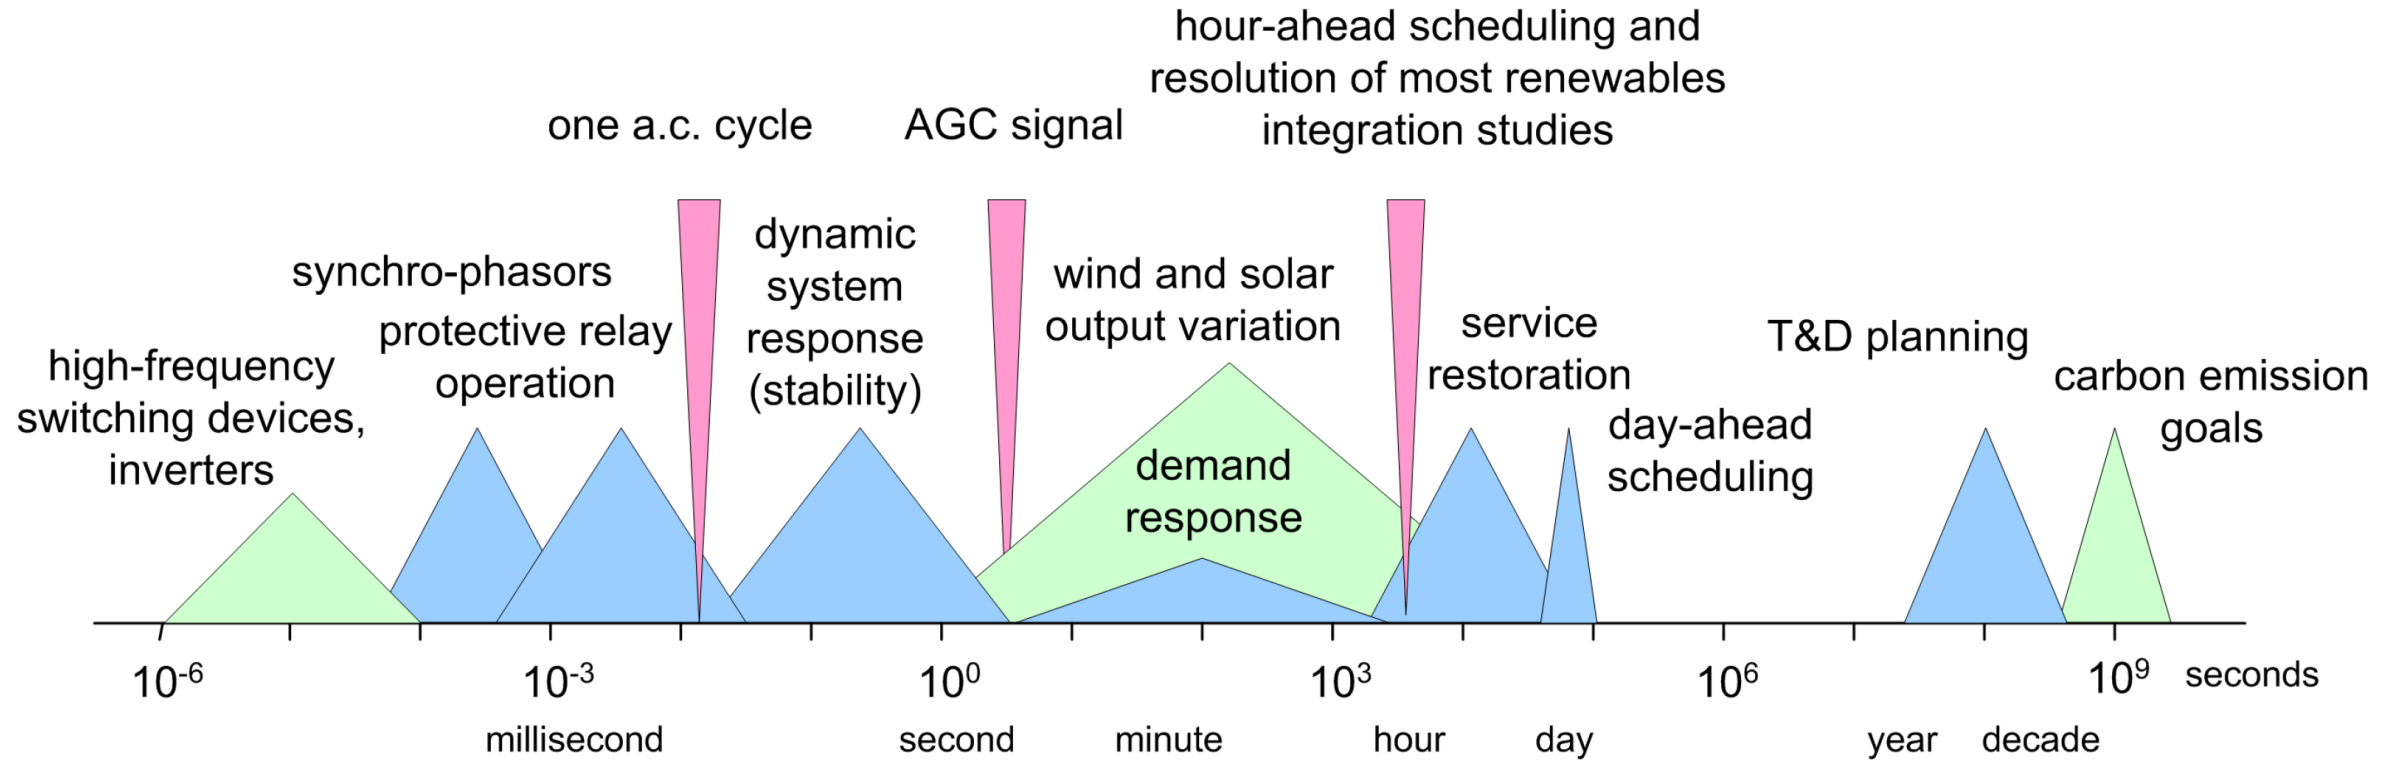
Figure 1. Time scales in electric grid operation.

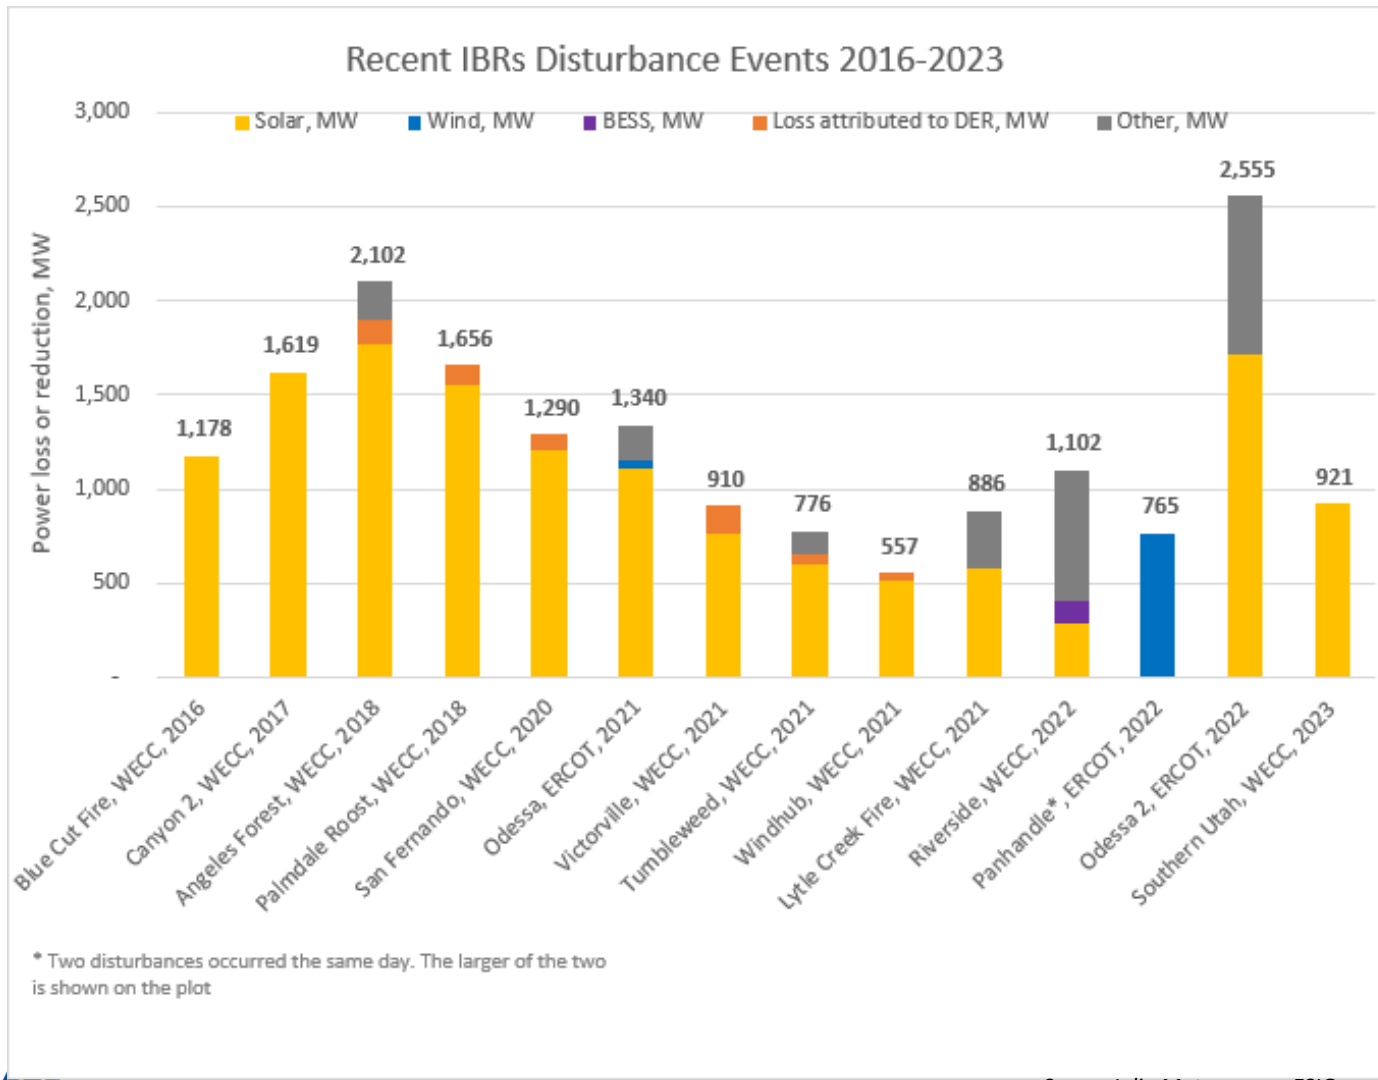
NERC established a 500 MW reporting threshold during this period for basic event analysis

WECC indicates a second event in Southern Utah under review

CAISO indicates two other events under review

Other smaller disturbances involving IBR did not lead to NERC event analyses or NERC reports

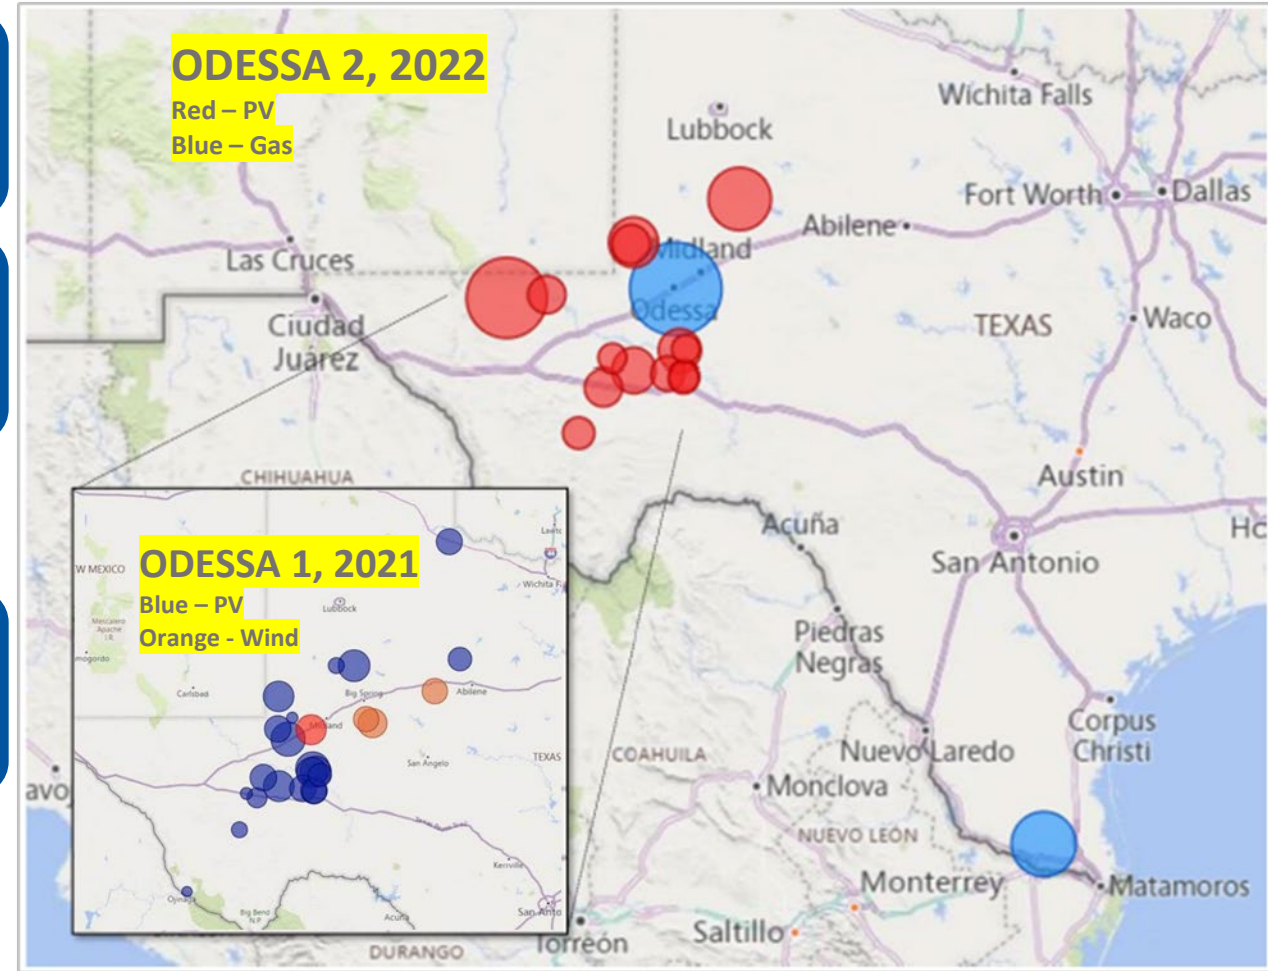
**345 kV single-line-to-ground fault at 12:59 PM CT, cleared normally in 3 cycles**

**2,555 MW generation loss (Category 3a event)**

- 844 MW loss of synchronous generation
- 1,711 MW loss of BPS solar PV generation

**Solar at Time of Event: 8,740 MW**

- 8,660 MW installed capacity
- 3,010 MW in commissioning

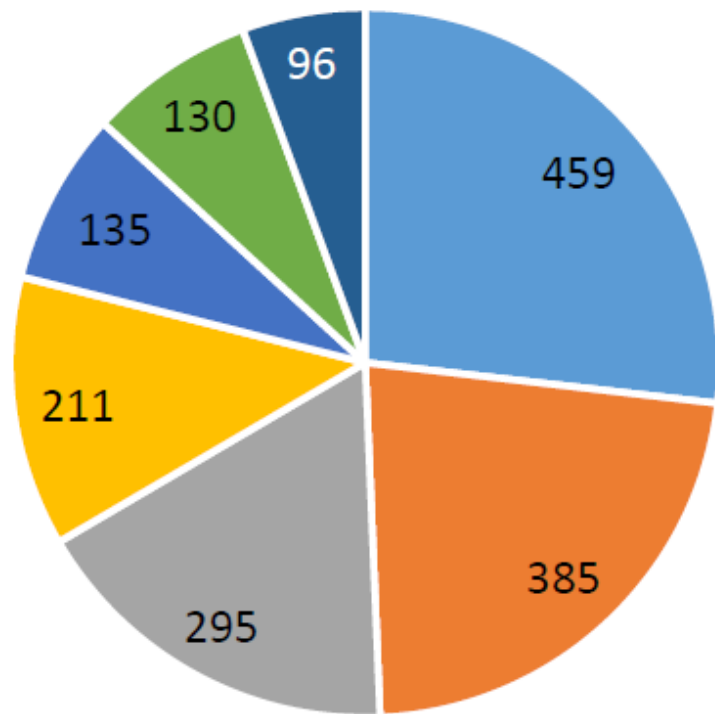
- Inverter Phase Jump
- Inverter DC Voltage Imbalance
- Momentary Cessation/Power Supply
- Inverter AC Overcurrent
- Inverter AC Overvoltage
- Incorrect Ride-Through Configuration
- Unknown

Cause of Reduction	Odessa 2021 Reduction [MW]	Odessa 2022 Reduction [MW]	
Inverter Instantaneous AC Overcurrent	–	459	✗
Passive Anti-Islanding (Phase Jump)	–	385	✗
Inverter Instantaneous AC Overvoltage	269	295	
Inverter DC Bus Voltage Unbalance	–	211	✗
Feeder Underfrequency	21	148*	
Unknown/Misc.	51	96	
Incorrect Ride-Through Configuration	–	135	✗
Plant Controller Interactions	–	146	✗
Momentary Cessation	153	130**	
Inverter Overfrequency	–	–	
PLL Loss of Synchronism	389	–	✓
Feeder AC Overvoltage	147	–	✓
Inverter Underfrequency	48	–	✓
Not Analyzed	34	–

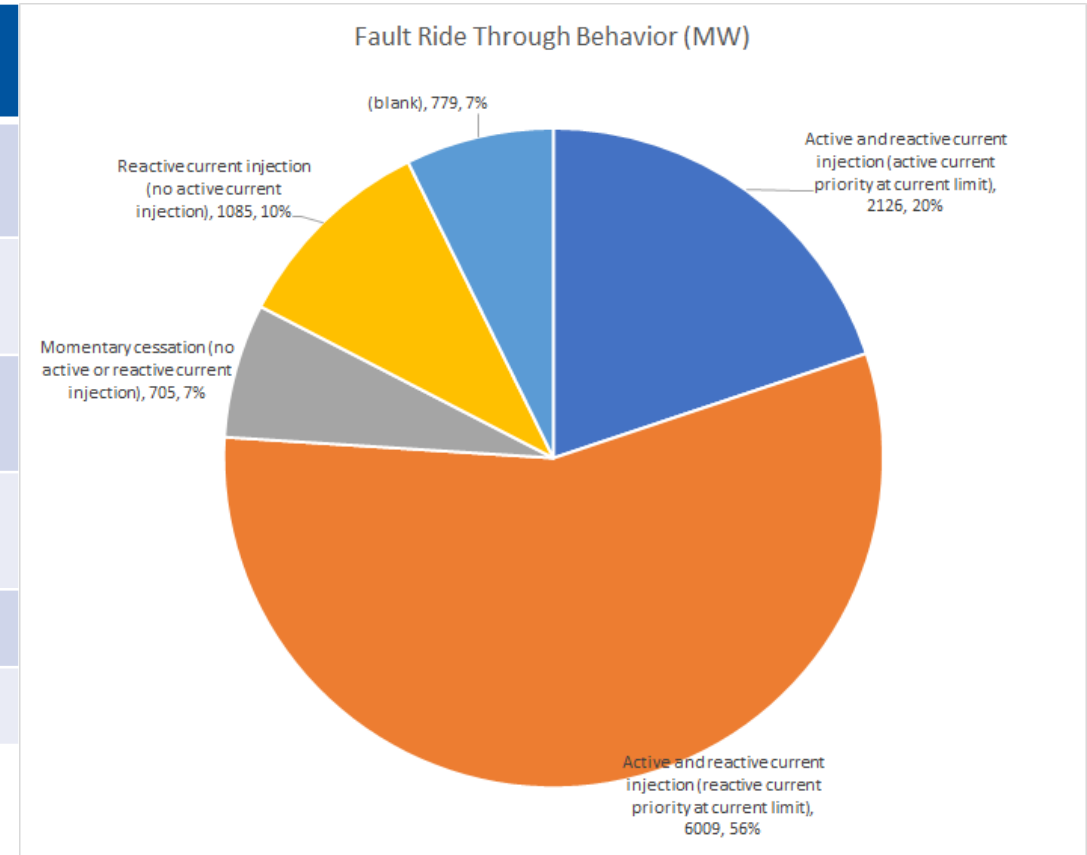
Fault ride-through behavior enabled at the facility	# Facilities	Nameplate MW Sum
Active and reactive current injection (active current priority at current limit)	9	2,126
Active and reactive current injection (reactive current priority at current limit)	32	6,009
Momentary cessation (no active or reactive current injection)	5	705
Reactive current injection (no active current injection)	5	1,085
No response	4	779
Grand Total	55	10,703

- Momentary cessation is undesired (two plants affected during 2022 Odessa event).
- Reducing active power to provide reactive also goes against the recent FERC order.
- Reactive current priority at current limit is the desired response for low voltage conditions.

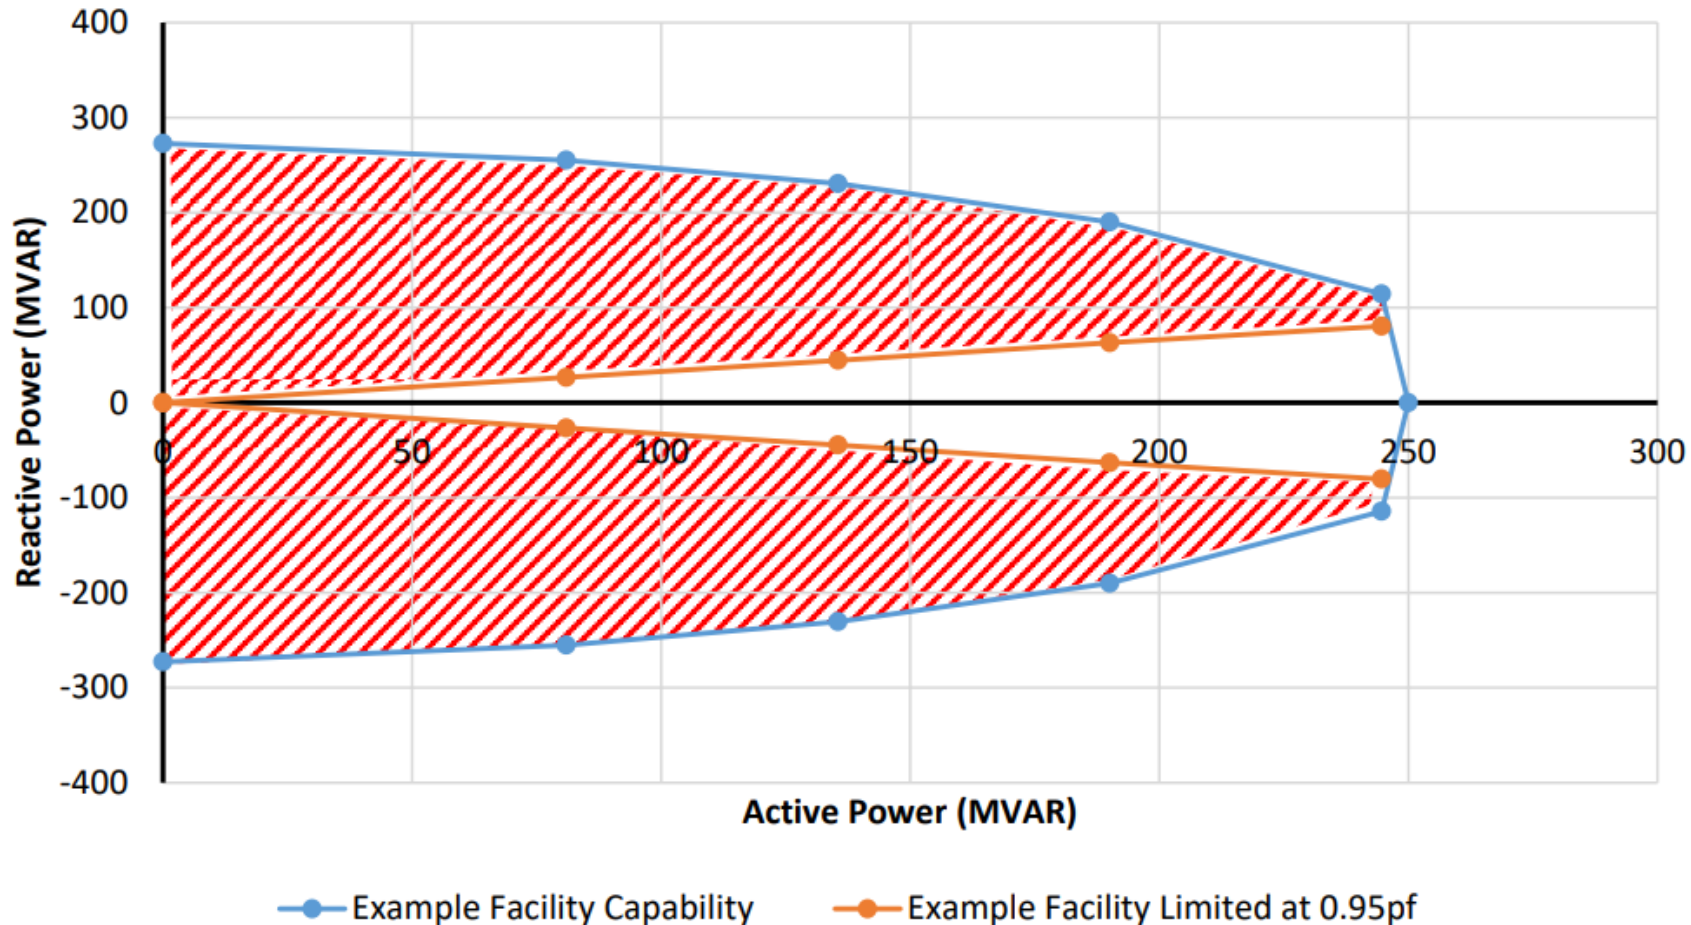
- ~35% of resources have the “triangle” shaped capability curve, potentially leaving significant reactive power capability unused
- Reactive capability artificially limited by plant controller settings
- Steady-state and dynamic reactive capability should be at least 0.95 power factor at maximum power output
